GLOBAL INDUSTRY STANDARD ON TAILINGS MANAGEMENT (GISTM)

Public Disclosure Report 2023

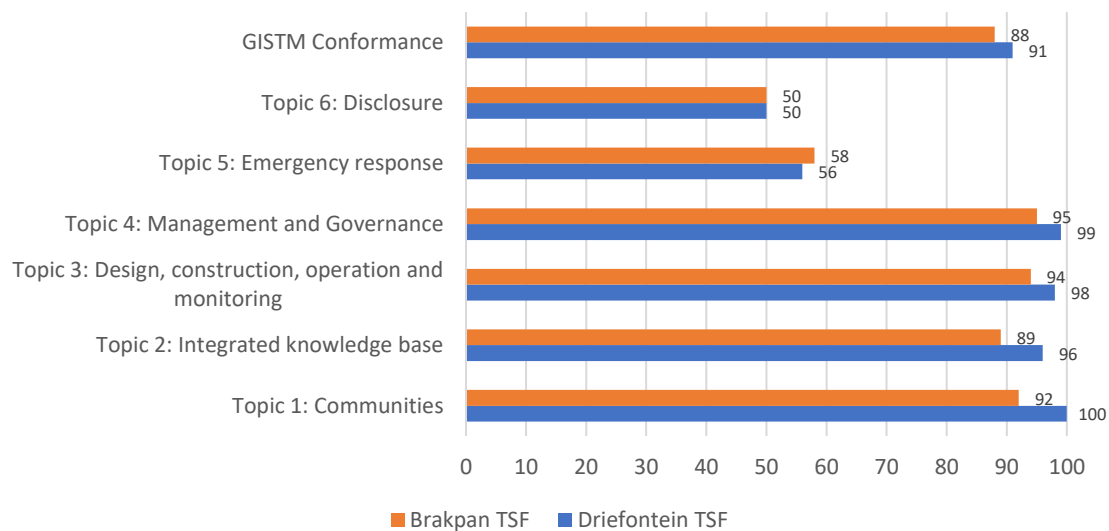
Figure 2: DRDGOLD GISTM Conformance: Operational dams

The overall GISTM conformance for the Brakpan/Withok Tailings Storage Facility (BTSF) amounts to 88% and the Driefontein 4 TSF overall conformance amounts to 91% (Figure 2). Topic 5: Emergency response and Topic 6: Disclosure are current improvement focus areas.

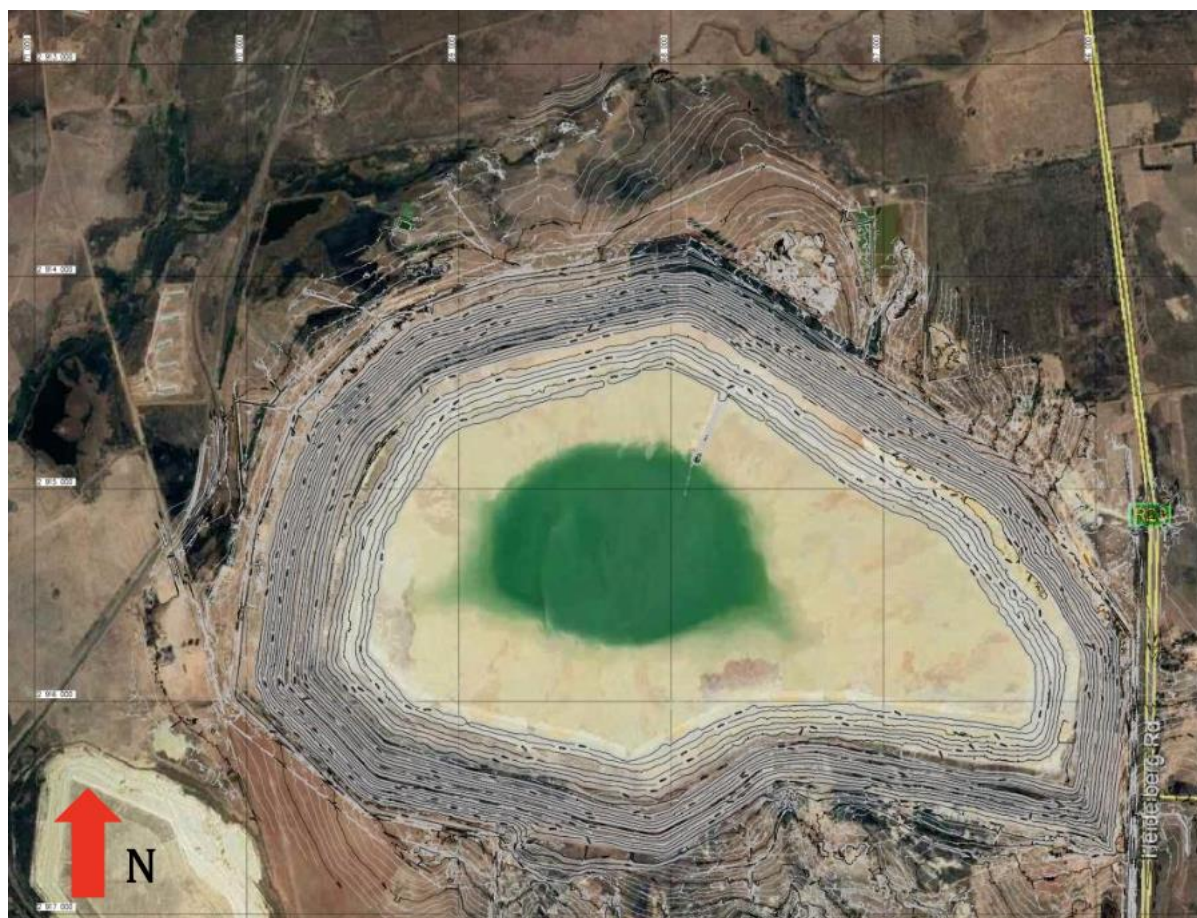
Figure 6: Contour plot of upper surface of BTSF

BTSF is an upstream on-wall cyclone ring dyke dam with a pumped decant. The footprint of the facility covers approximately 900ha, with a current height of 120m and future maximum height of approximately 150m. A contoured plan layout of the TSF is presented in Figure 6.
